APPLICATION OF GPR DURING INVESTIGATION CONCERNING CAUSES OF PAVEMENT FAILURE AND ROAD SUBGRADE QUALITY IN GRANITOID MASSIF NEAR SIMTANY

Luděk KOVÁŘ¹, Pavel POSPÍŠIL²,

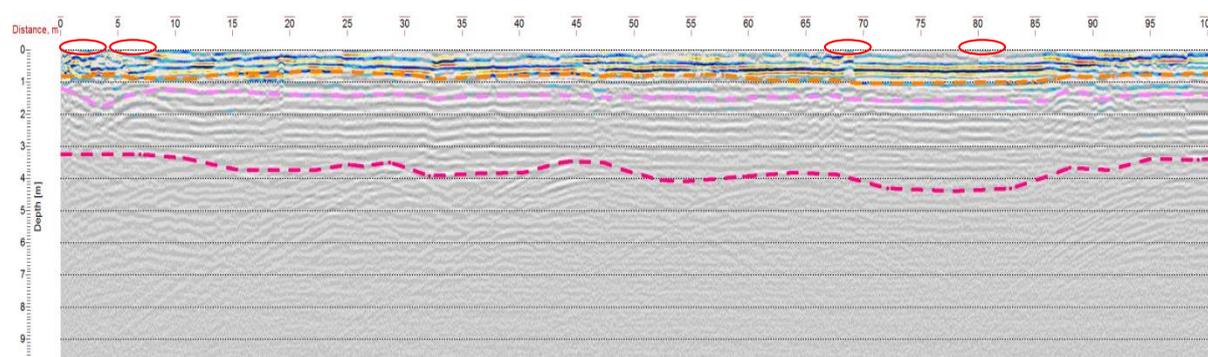
On the basis of the measurements performed within the shoulders of the road, the likely level of a depth boundary of the surface of highly weathered granites (category 4 and less weathered) depicted by the red dashed line (Fig. 6 and 7) was established during interpretation.

In all the studied profiles, the probable interface of overburdens (both natural and anthropogenic) and highly weathered granites below the road in depths (from the surface of the pavement), ranging from about 1.3 to 1.6 m, was interpreted. In radargrams, this line is represented with a pink dotted line.

The depth of the interpreted interfaces is encumbered with an error quantified at about 10 % due to the variability of dielectric properties of the rock mass in the measured profiles.

Fig. 6 The radargram of the selected portion of the longitudinal profile measured with GPR in the shoulder of the road with the interpretation of each interface (surface of granites - red, highly weathered granites - pink, eluvium - orange). The red ellipses highlight the examples of inhomogeneities in structural layers of the road.

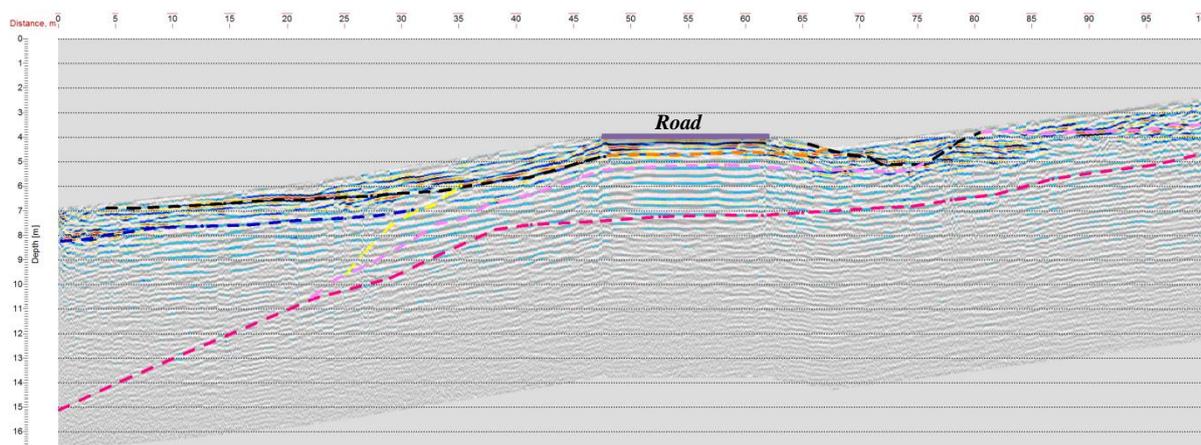
Fluvial sediments occur in the base of the slope where they are overlapped by pond sedimentation. The thickness of sediment deposits was detected by the radar on the profile P2 in the value of about 2.0 m, by the archival probe V-1306 situated almost in the middle of the floodplain of the Sázava River then in a value of 3.5 m.

Fig. 7 The radargram of the selected part of the cross section area measured with GPR from the alluvial floodplain area near the pond against the slope NE with the interpretation of each interface (surface granites - red, highly weathered granites - pink, eluvium - orange, deluvium - yellow, alluvium - blue, anthropogenic layers - black).

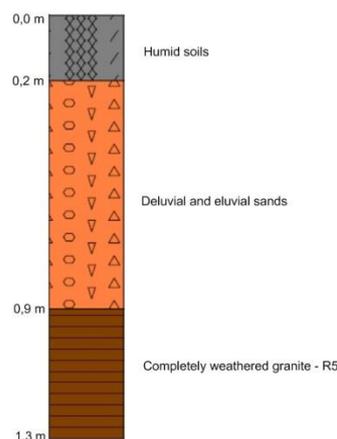
Fig. 8 A simplified profile of the manually drilled probe Rv-2

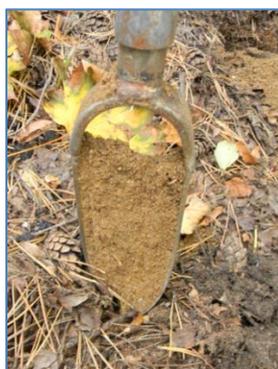
Fig. 9 The example of the yield of disintegrated (residual soil - R6) to completely weathered biotite granites (completely weathered - R5) to coarse-grained sands by hand drilling.
