NON-INVASIVE GEOPHYSICAL INVESTIGATION OF FAILURE ALONG A SECTION OF AGO-IWOYE MARKET ROAD, AGO-IWOYE, SOUTHWESTERN NIGERIA

ABSTRACT

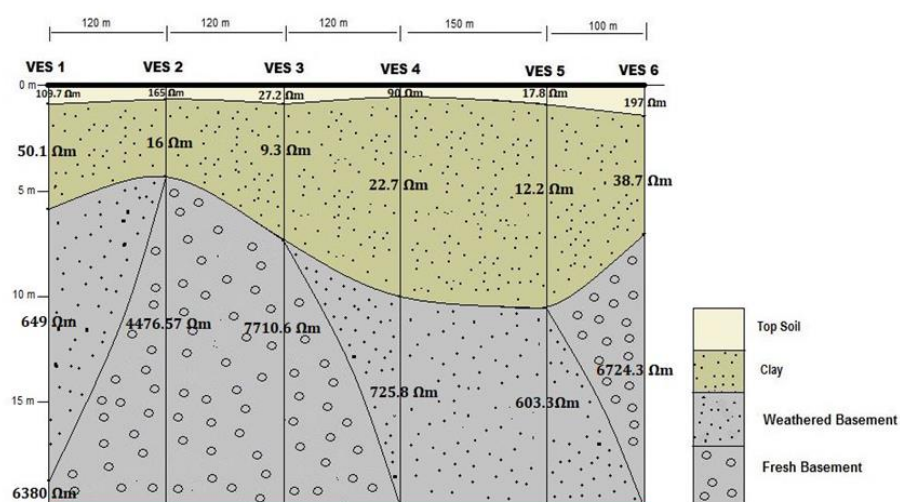
Figure 3. Geoelectric section of VES points on profile showing depth, resistivity and the correlation of lithology along the traverse

The results of the VES inversion produced the geoelectric parameters in the form of layer resistivity, depth, thickness, and lithology, and are presented in Table 1 below. The geology of the study location, which is a basemey terrain, aided in the inference of the lithology of the study area to be topsoil, weathered materials (clay, sandy clay, clayey sand, sand), and basement rock, which helped to classify the subsurface into competent, moderately competent, and incompetent zones. The curve types obtained in the area are H, HA, and KH, which means the subsurface is three to four layers, the topsoil and weathered layer are composed of clay, sandy clay, and clayey sand, with clay being the predominant material while the basement rock is fresh, weathered, or fractured. The resistivity of the topsoil varies from 17.8 to 197 Ωm and has an average thickness of 0.85 m, the weathered layer has a resistivity range of 9.3 to 50.1 Ωm , and the basement rock has a resistivity range of 603.3 to 7710.6 Ωm . A summary of the VES results can be seen in Table 1, and a cross section of the six VES points on the profiles can also be seen in Figure 3. It can be seen that the resistivity of the topsoil and the weathered layer for all the VES points are $<200 \Omega\text{m}$ and the roads are in poor to bad conditions. VES 1, 3, 4, and 5 have topsoil resistivity values between 17.8 and 109 Ωm , which corresponds to clay and sandy clay soils which are incompetent soils that should not be used for construction. While VES 2 and 6 have resistivity values of 165 and 197 Ωm , which corresponds to more competent clayey sand, the layer is not thick enough (0.5–1.4 m), and also the weathered layer beneath all the VES points is filled with clay (9.3–38.9 Ωm), the very low resistivity means the conductivity is higher, showing that the clay contains a high moisture content. This low resistivity is proof that soil is not ideal for engineering construction due to the absence of drainage, low shear strength, and high compressibility. From lithology (Table 1), it can be inferred that clay $<100 \Omega\text{m}$ is incompetent, sandy clay is moderately competent, clayey sand is competent, and the basement is competent when not fractured and present at a shallow depth.

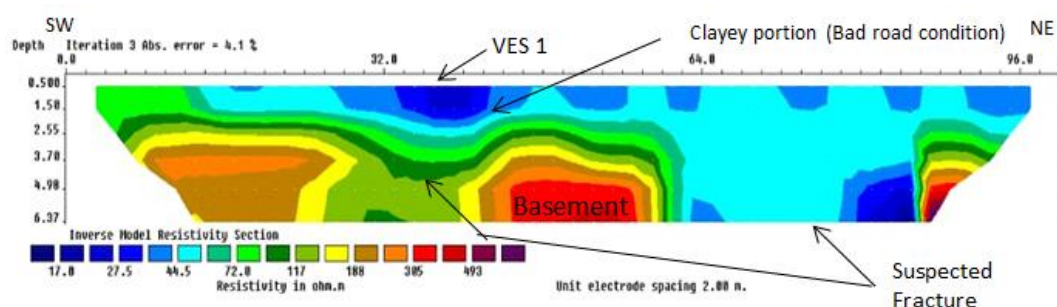
Figure 4. A 2D electrical resistivity image of profile 1

Interpretation of profile 1: bad road portion; the electrical image shows that the study area reveals the presence of 3 lithological layers corresponding to the topsoil, the weathered layer, and the basement in VES1 (Figure 4). The RMS error is 4.1 %, and the electrical image shows shallow to near-surface layers, the resistivity of which is between 17 to 120 Ωm and a thickness of about 4.5 m, which shows that the topsoil down to the weathered layer is clayey to sandy clay. It is quite similar to VES1 and not competent for engineering construction because there would be a differential settlement of the sub-base and sub-grade, which will lead to failure. There are also low resistivity areas between high resistivity, which is diagnostic of a shallow fracture/fault present at the southern and middle part of the profile, which could also have contributed to the failed section.

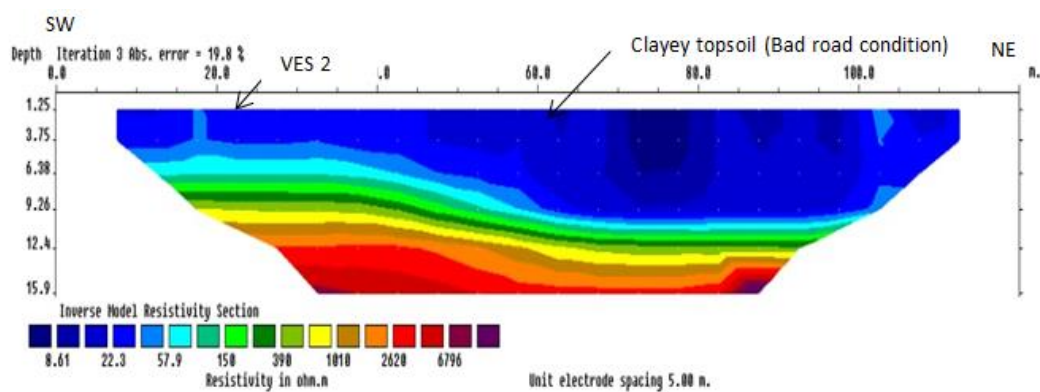
Figure 5. A 2D electrical resistivity image of profile 2

Interpretation of profile 2: bad road condition; the electrical image shows that the study area reveals the presence of 3 lithological layers corresponding to the topsoil, the weathered layer, and the basement in VES 2 (Figure 5). The electrical image shows shallow to near-surface layers, the resistivity of which is between 10 and 200 Ωm with

a thickness of about 7 m, below there are layers with higher resistivity, which means the entire near-surface is mostly clayey in nature, which is not competent material for road pavement construction. A portion of the profile has a resistivity between 10 and 60 Ωm , indicating a highly saturated zone with high moisture content, as clay swells upon absorbing water and shrinks on drying, which is likely responsible for the potholes seen in this road section.

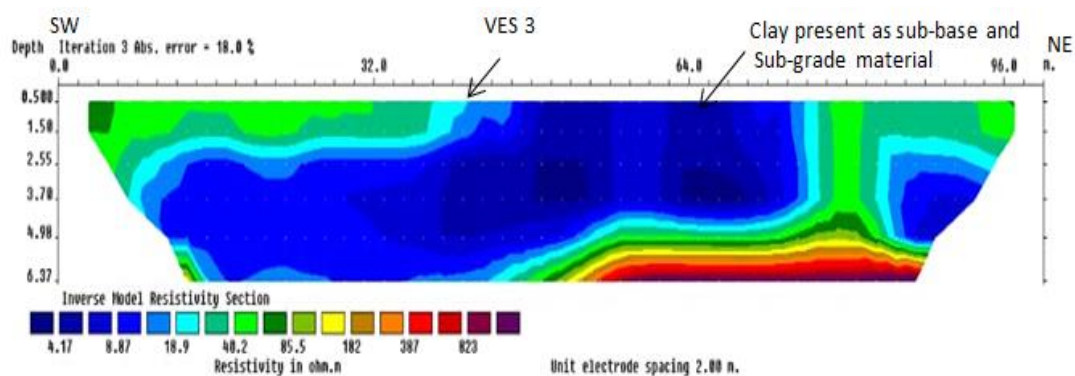
Figure 6. A 2D electrical resistivity image of profile 3

Interpretation of profile 3: bad road condition; the electrical image shows that the study area reveals the presence of 3 lithological layers corresponding to the topsoil, the weathered layer, and the basement in VES 3 (Figure 6). The electrical image shows shallow to near-surface layers, the resistivity of which is between 9 and 100 Ωm with a thickness of approximately 4.5 m, which means the entire profile is clayey. In the presence of clay, the permeability of a geotechnical material decreases [19] as it can retain water. The mid-region of the profile has a resistivity between 10 and 25 Ωm , indicating a highly saturated zone with high moisture content. The darkest part of the middle portion is within the weathered layer and has a very low resistivity of <10 Ωm indicating a weathered layer of VES 3. This low-resistivity soil is likely responsible for the bad state of the road section.

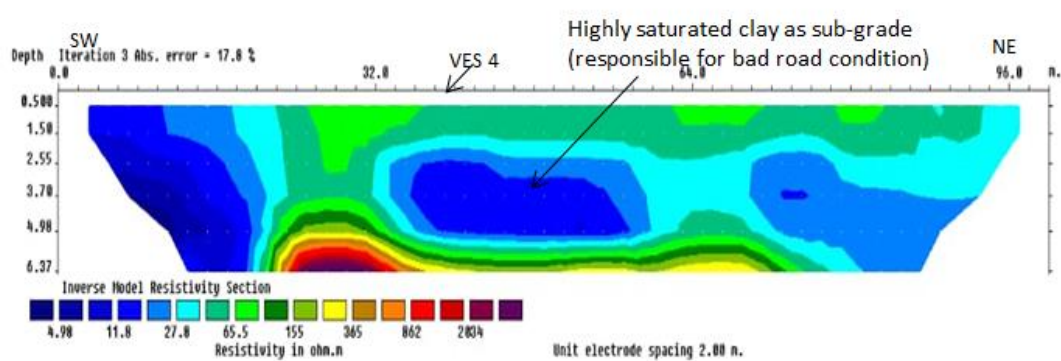
Figure 7. A 2D electrical resistivity image of profile 4

Interpretation of profile 4: bad road condition; the electrical image shows that the study area reveals the presence of 3 lithological layers corresponding to the topsoil, the weathered layer, and the basement in VES4 (Figure 7). The electrical image shows shallow to near-surface layers, the resistivity of which is between 12 and 100 Ωm with a thickness of about 5 m, which means the entire near-surface is clayey. The dark blue portions of the profile have resistivity <30 Ωm , which is a highly saturated zone that occurs at different depths along a lateral distance of 0 to 100 m of the traverse. It may have helped to differentially settle the subgrade and then the subsequent failure of the road section [20, 21]. The lower middle portion is within the weathered layer and has a very low resistivity between 20 and 30 Ωm , which corresponds to the weathered layer of VES4. A large pothole was present at the time of the survey; other sections of this road will soon follow as vehicles continue to ply the road.

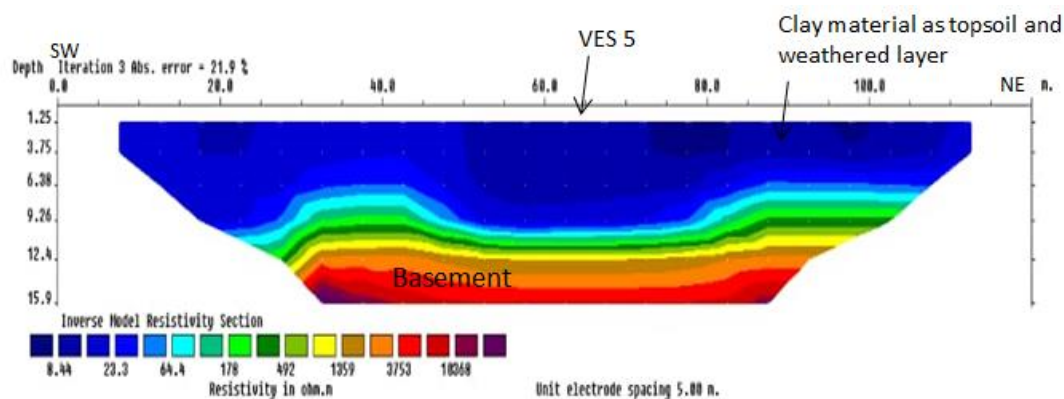
Figure 8. A 2D electrical resistivity image of profile 5

Interpretation of profile 5: fair road condition; the electrical image of this profile reveals the presence of 3 lithological layers corresponding to the topsoil, the weathered layer, and the basement, as in VES 5 (Figure 8). The image shows shallow to near-surface layers, the resistivity of which is between 8 and 200 Ωm with a thickness of about 10 m, which means the entire near-surface is clayey. The deep blue portions of the profile have resistivity <50 Ωm , indicating a highly saturated zone with high moisture content that may be responsible for road conditions because there is a differential settlement as vehicles move over them. Although this road is not as bad as the others, there are signs all over the pavement that it will fail soon.

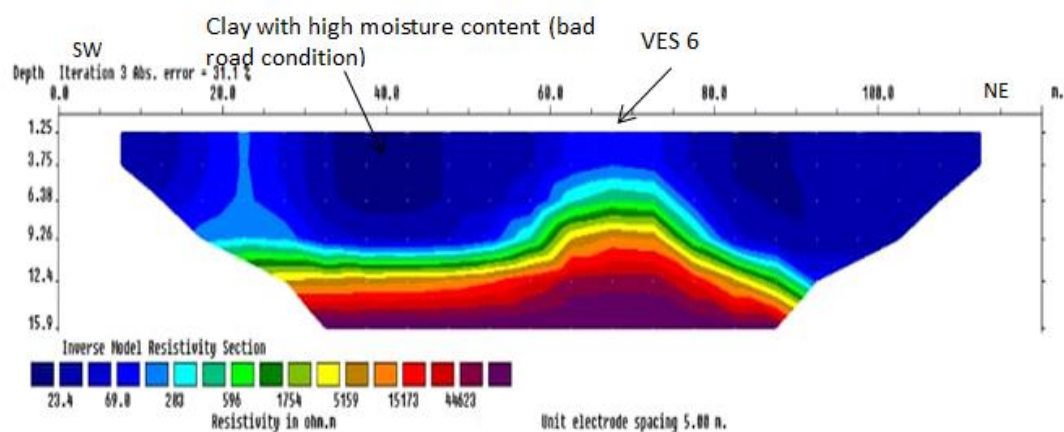
Figure 9. A 2D electrical resistivity image of profile 6

Interpretation of profile 6: bad road portion; the electrical image shows that the study area reveals the presence of 3 lithological layers corresponding to the topsoil, the weathered layer, and the basement in VES 6 (Figure 9). The electrical image shows shallow to near-surface layers, the resistivity of which is between 23 and 250 Ωm and a thickness of about 10 m, which shows that the first few meters are mostly clayey with a small amount of clayey sand. It is not competent for engineering construction because there would be differential settlement of the sub-base and sub-grade, which could lead to failure and may be responsible for the bad state of the road section.
